Routzahn-Summers Farmstead  
Myersville vicinity  
Private

# Maryland Historical Trust State Historic Sites Inventory Form

## MARYLAND INVENTORY OF HISTORIC PROPERTIES

historic Routzahn-Summers Farmstead

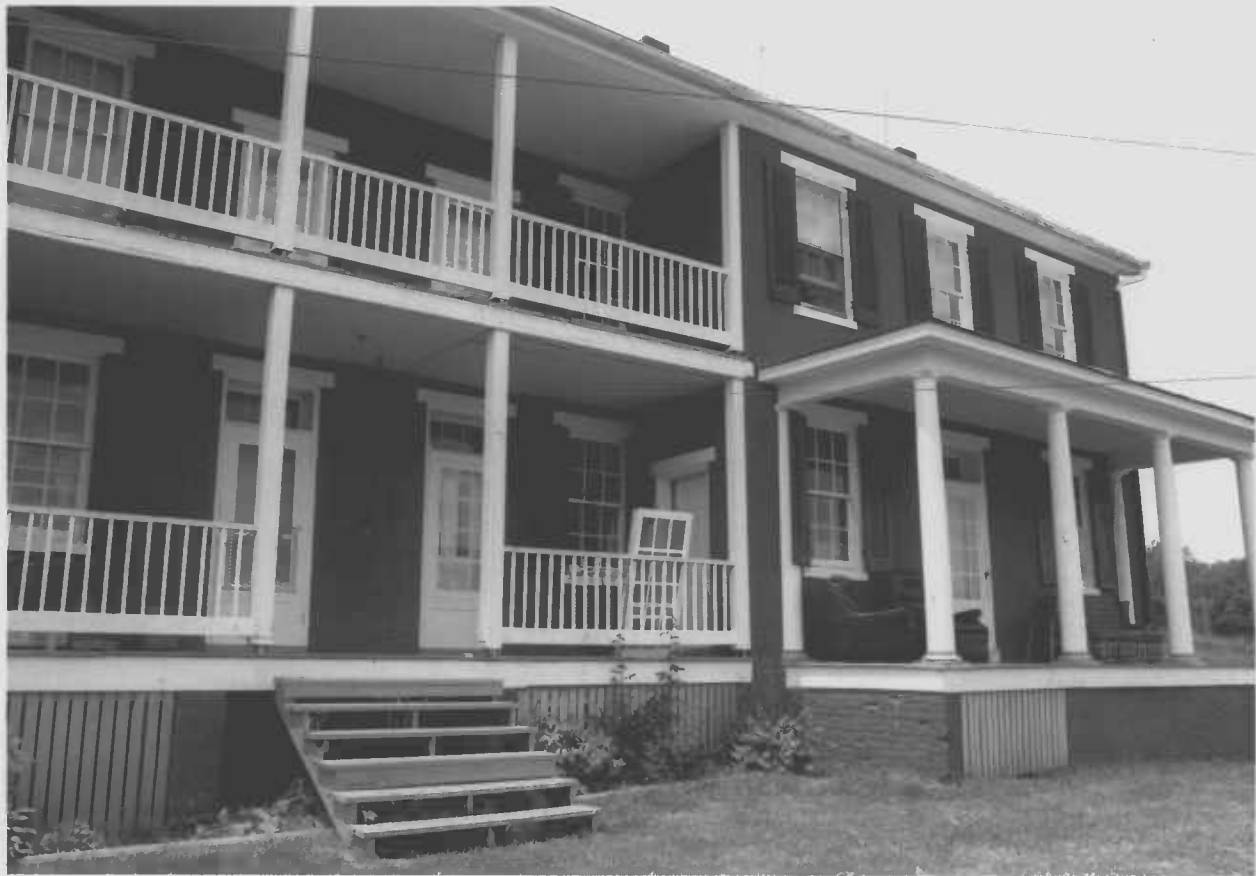
1/6

Neg. loc: Md. SHPO Crownsville Md.  
East elevation

The dwelling has two sections, a three-bay main section on the north and a four-bay wing on the south with an integral two-story porch. Both sections face east. The walls are laid in 5:1 American bond and are painted brick red. The three-bay section has a center entrance and a one-story porch with Tuscan columns, which was probably added in the period 1905-1910. The window and door openings have plain lintels and sills and the doorway has a three-light transom. The door has 6 panels. The sash is 6/6 with louvred shutters. The cornice is boxed and the roof is covered with corrugated metal. The chimneys are at each gable end and at the joining wall between the main section and wing. The wing has a plain balustrade and square posts on each level. The four bays have two entries in the inner bays. One of the doors has glazed upper panels, while the other has four solid panels. The bases of the porches on both the main section and the wing have brick pedestals, perhaps indicating that these were built in the early 20th century to replace earlier porch foundations. The north elevation has two bays with 6/6 sash and two attic windows with 2/2 sash. The west elevation has an irregular bay arrangement, with three bays in the center flanked by incomplete bays at each end of the house. The northernmost bay has a door to the rear of the main section under a small shed roof. The southernmost bay in the wing section has a similar entrance sheltered under a small entry porch, which was probably added in the early 20th century. The interior of the house was inaccessible for this survey.

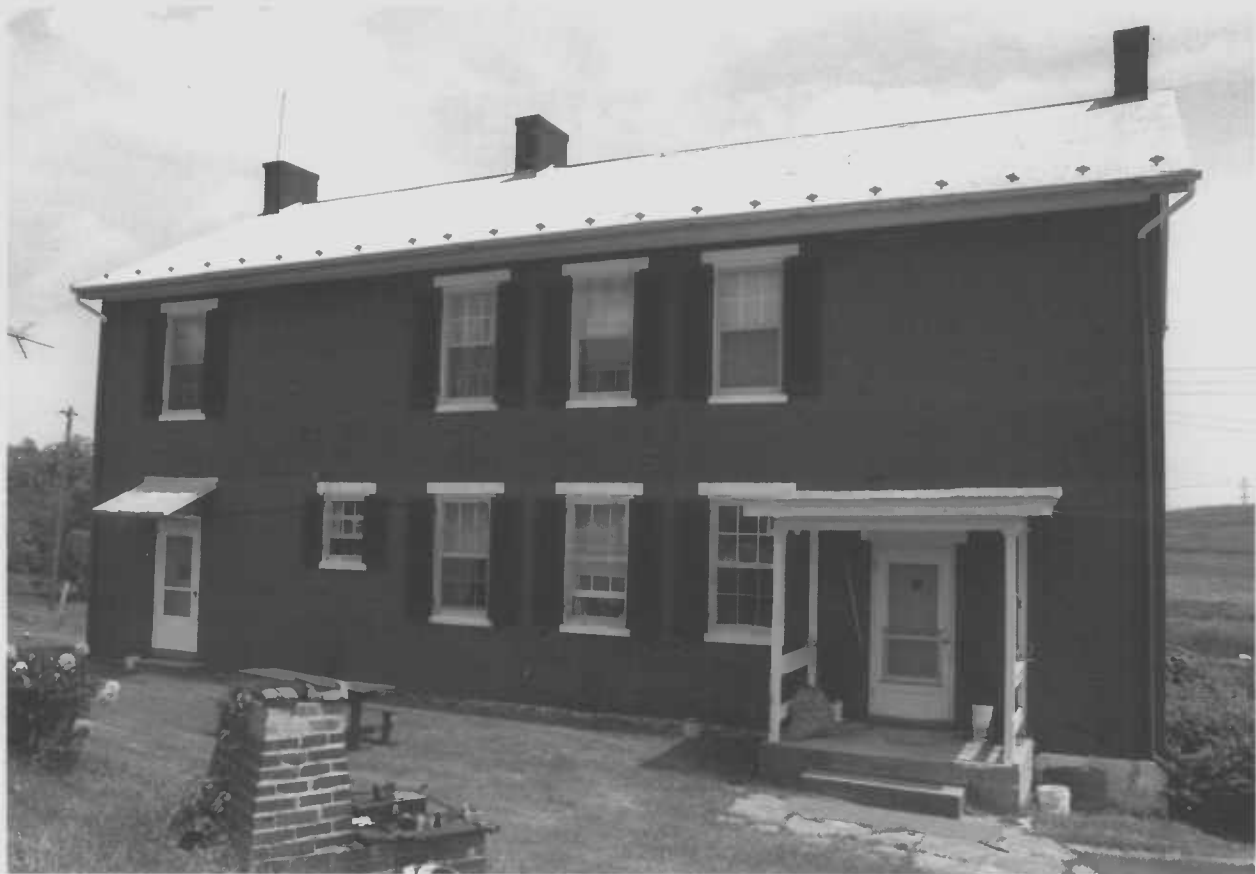
2/6

Neg. loc.: Md. SHPO, Crownsville, Md.  
West elevation

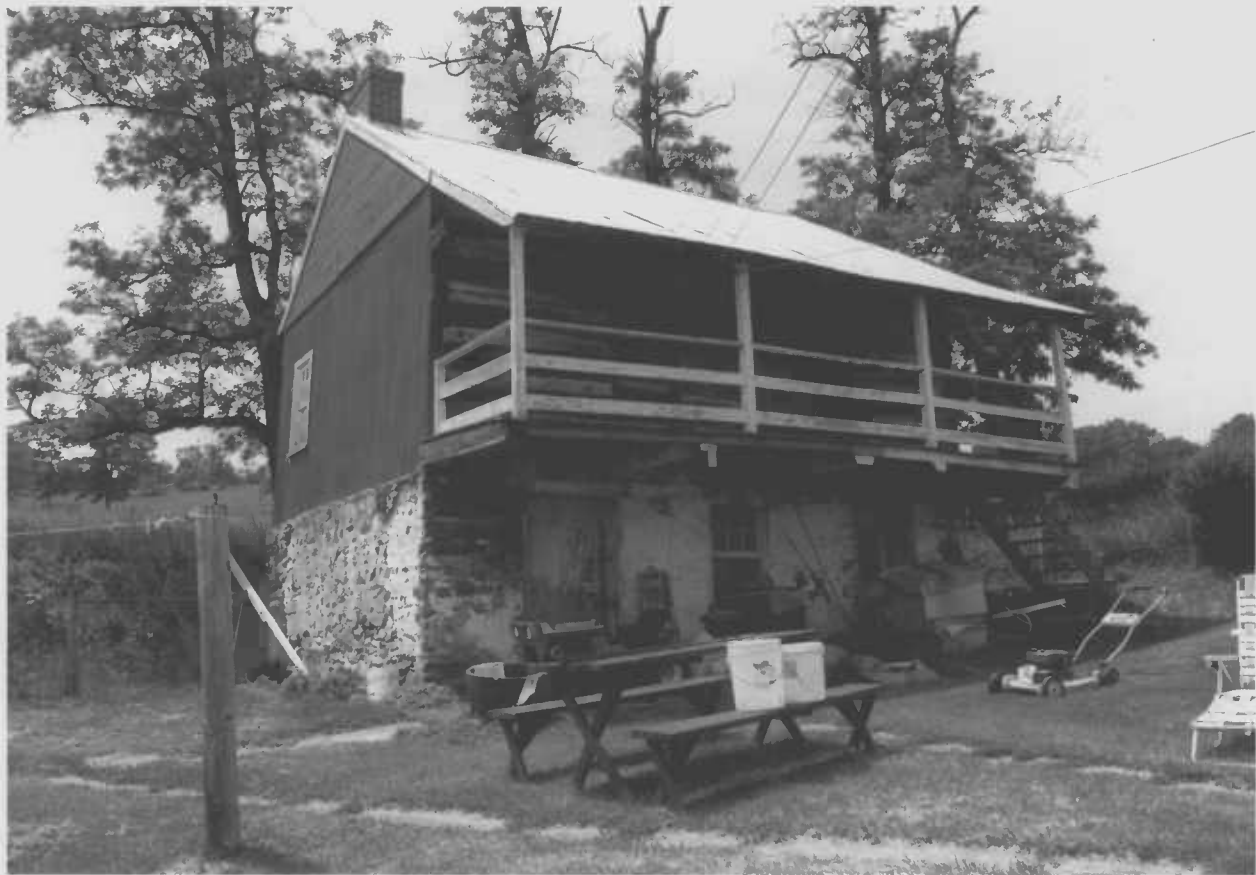
3/6

Springhouse, northeast elevation

Springhouse: The stone and log springhouse is a two-story building located southwest of the house and placed diagonally to the plane of the house. The stone first level has three openings on the northeast elevation with doors in the outer bays. One of these at the southeast corner is a vertical board door, while the other has a an open or glazed panel. The center bay has a 6/6 window. The fieldstone walls were once whitewashed and some of this survives on the northeast elevation. The second story of the springhouse is exposed log on the northeast side, but the log structure is covered with corrugated metal siding on the other elevations. The second story has a cantilevered porch with a side access stair and a plain horizontal railing with square posts. The second story has two bays with a vertical board door and a 6/6 window. The roof is covered with corrugated metal and

an interior end chimney rises at the south gable end. The springhouse interior was inaccessible, so the determination of the use of the upper level is incomplete. It may have been a summer kitchen, slave quarters, or a wash house. Its date appears to be contemporary with the house; however, it is possible that the building could pre-date the brick house by 20-25 years, and may have been the first residence on the farm.

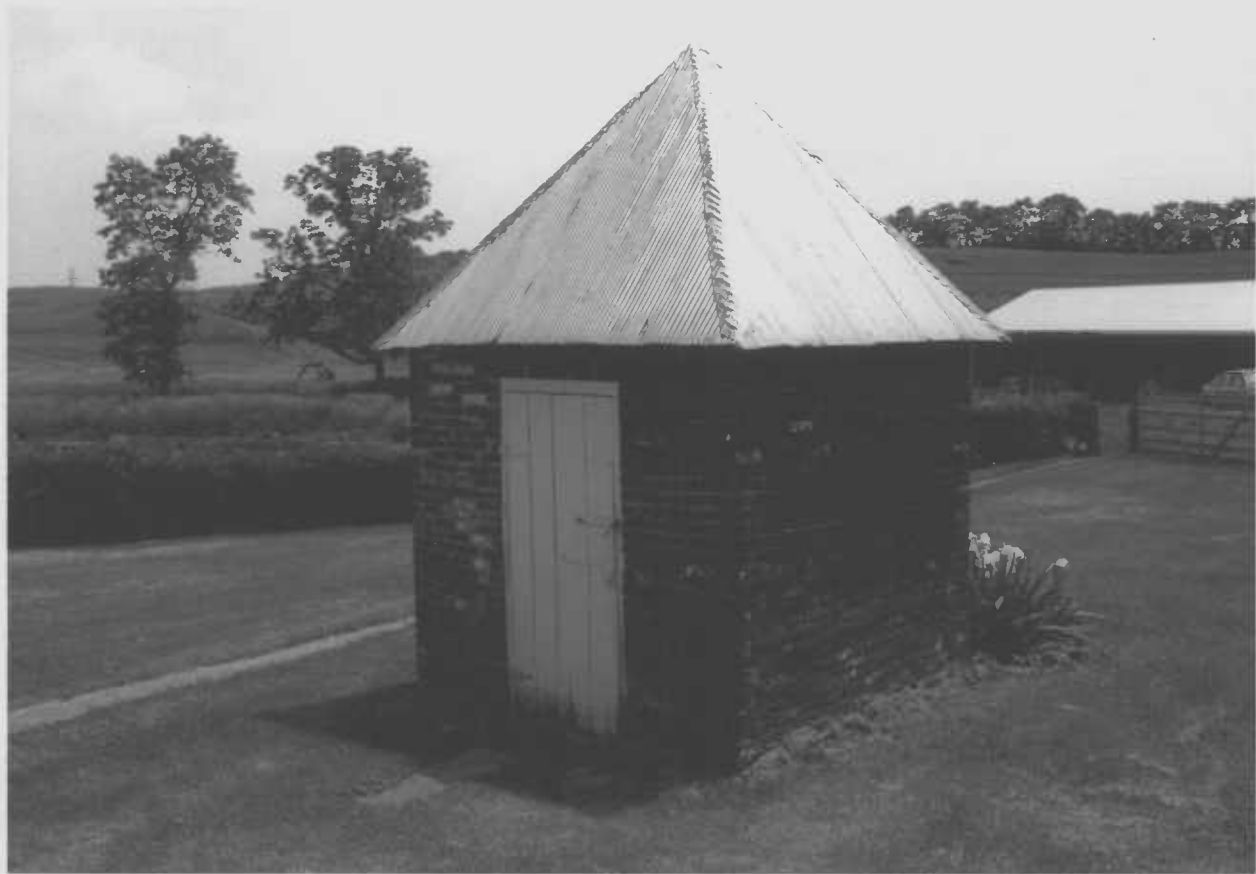
4/6

Smokehouse west elevation

**Smokehouse:** The square plan brick smokehouse is located south of the house. It has a hipped or pyramidal roof covered with corrugated metal. A single vertical board door is in the north elevation. This building also appears to have been built during the same period as the brick dwelling.

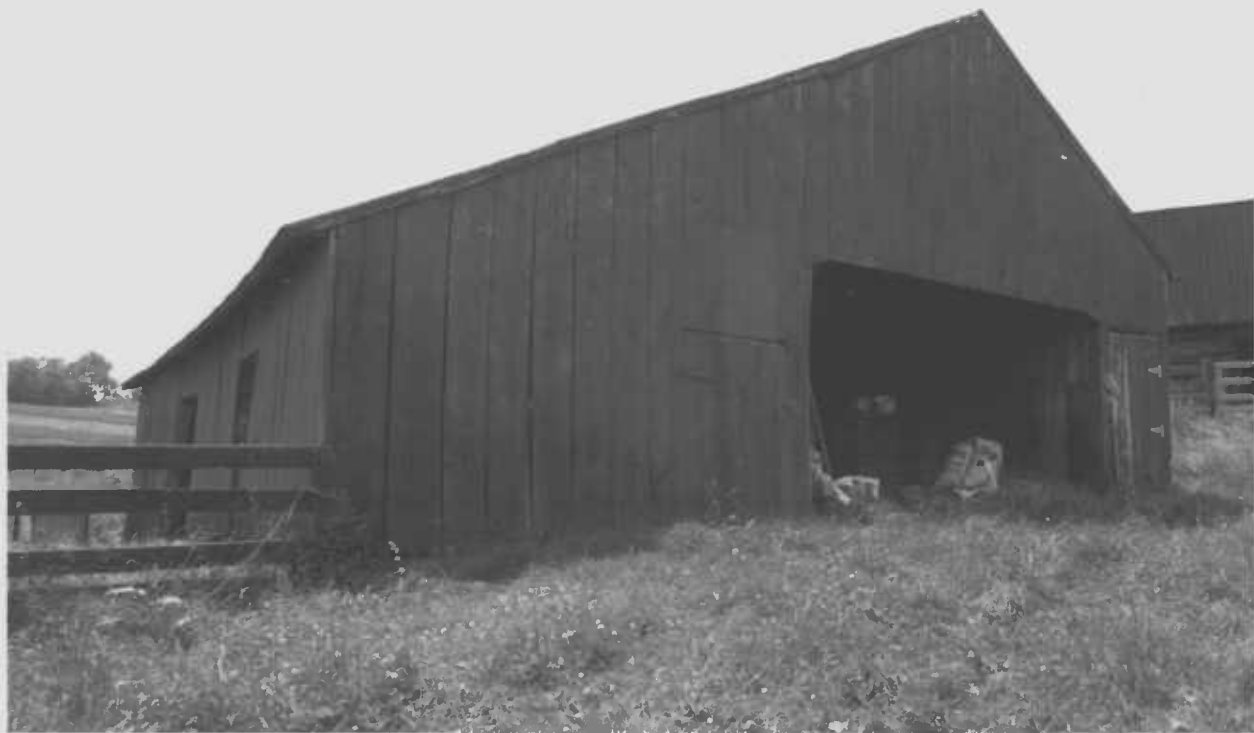
5/6

Wagon shed / hog barn, north elevation

**Wagon shed/hog barn:** The frame wagon shed with its attached hog barn was built in the first decade of the 20th century. Located east of the barn, the wagon shed has a single bay on the north elevation with vertical siding and a corrugated metal roof which extends to the east to cover the hog barn. The barn section has two open doorways on the east elevation. The entire shed is now used as storage space.

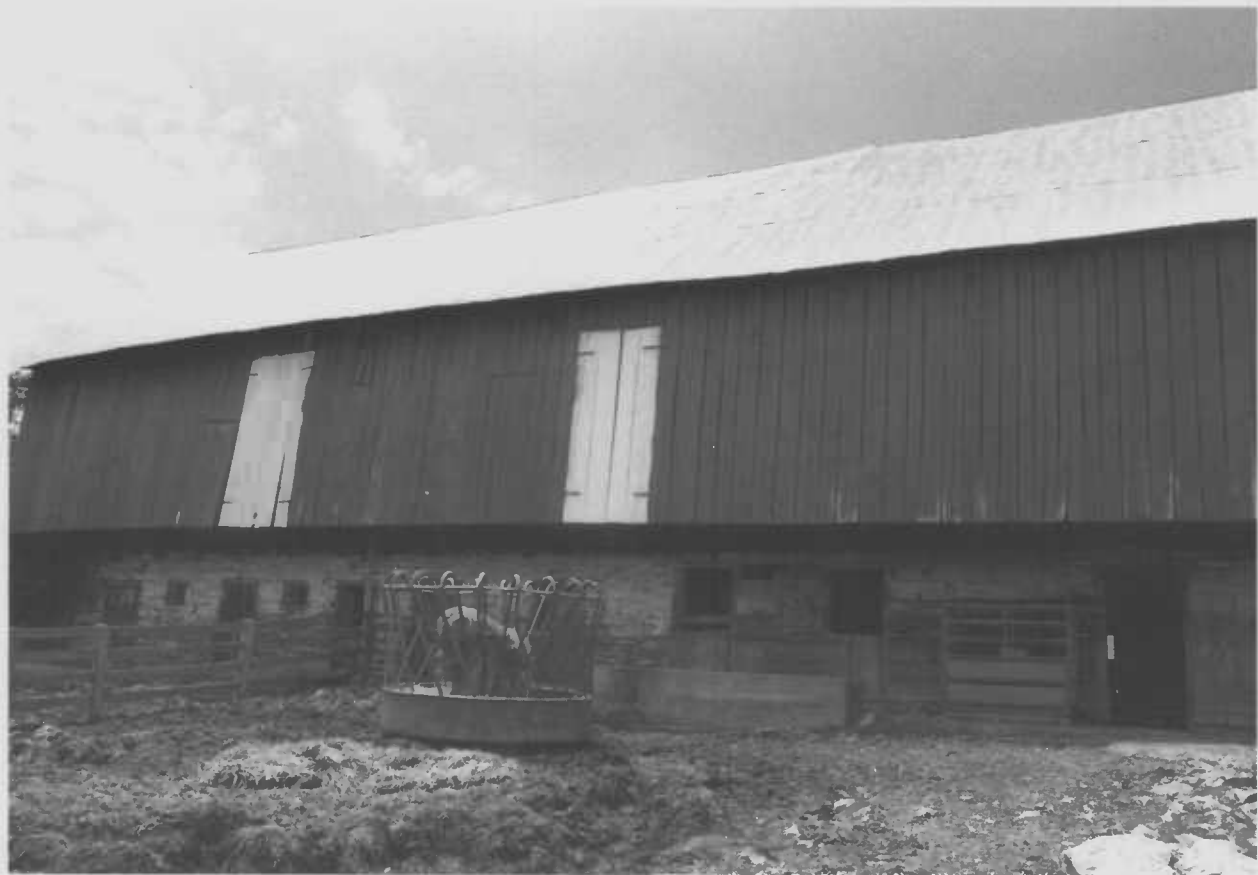
6/6

Born, east elevation

**Bank barn:** The large frame and stone back barn is located southwest of the house. Originally built in the first or second quarter of the 19th century, it was probably enlarged during the first decade of the 20th century. The foundation and stall level on the east are fieldstone which has been whitewashed in the past and still survives on the older section of the barn in the souther portion of the building. The northern section, which is indicated by the stalls section enclosed by flush horizontal boards, is the early 20th century part. The upper section of the barn has vertical siding and two swing doors painted white on the east elevation. The roof is covered with corrugated metal. The barn is still in use as a cow barn.
